# Manhole Inspection Summary

Manhole # S51C\_\_048MH

Insp Date: **5/5/08 10:32 AM**

**Location** Address: **1 n decker ave**

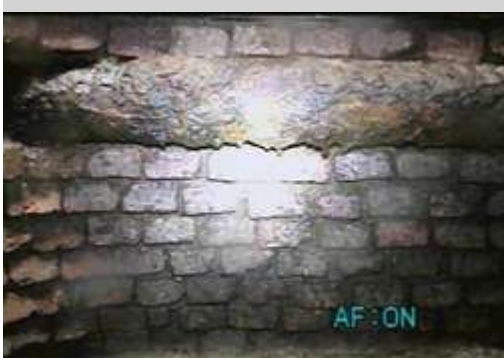
Defect 3

Condition: ☐ Sound ☐ Cracked ☐ Root Intrusion ☐ Loose Brick ☒ **Deteriorated**

chimney\_cond\_deteriorated

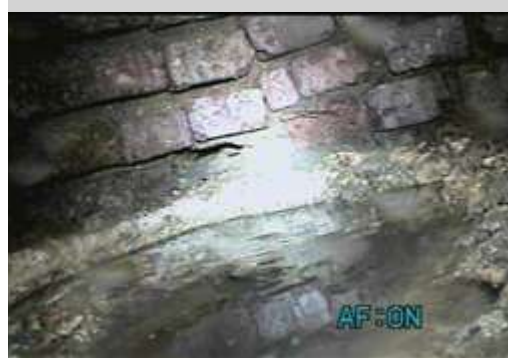
Defect 2

Condition: ☐ Sound ☐ Cracked ☐ Root Intrusion ☐ Loose Brick ☒ **Deteriorated**

Barrel\_cond\_deteriorated

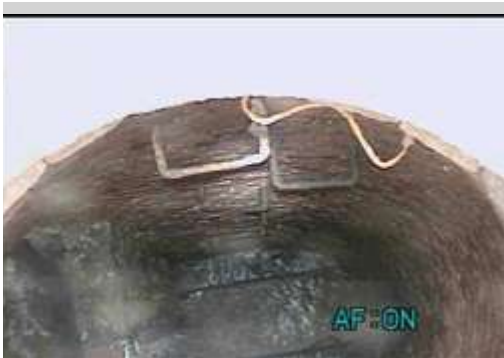
Defect 1

**Steps** Count: **7** Missing: **5** ☒ **Corroded**

steps

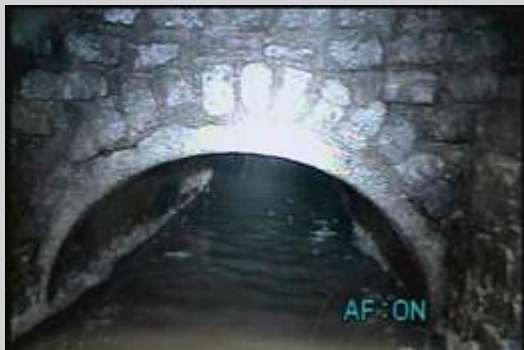
12 O'Clock Outflow

27 in. Circular Gravity Sewer  
Pipe Out @ 12 O'Clock

Invert Depth: 17.19 (ft.) Flow Characteristics: **Fast**

Infiltration: **None** Pipe Seal Cond: **Unknown**

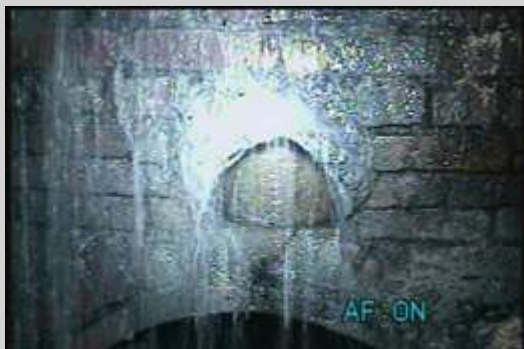
6 O'Clock Inflow

27 in. Circular Gravity Sewer  
Pipe In @ 6 O'Clock

Invert Depth: 8.17 (ft.) Flow Characteristics: **Fast**

Infiltration: **None** Pipe Seal Cond: **Unknown**

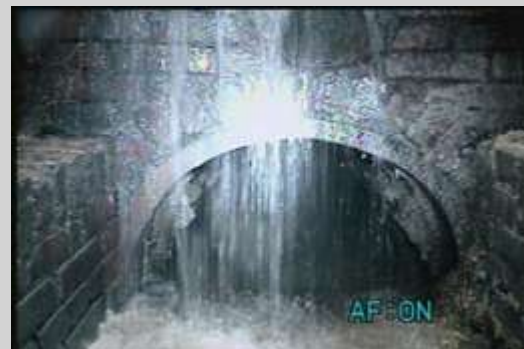
Drop In @ 6 O'Clock

Drop: **Outside Direct**

Inv Depth: 17.15 (ft.)

Drop Condition: **Open**
